Homeworks Inspection Services, LLC
2362 E. Gloucester Place
Boise ID 83706
208-866-1578
homeworks@cableone.net
www.homeworksinspect.com
File Number: 2010188
Report Address: 12345 N. Anywhere Place

Confidential Inspection Report

12345 N. Anywhere Place
Eagle, ID 83616

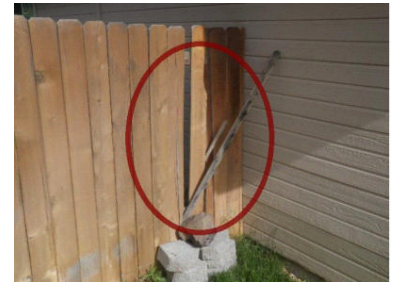
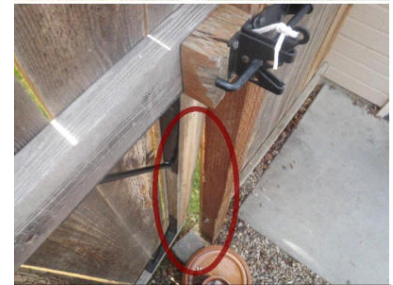
CONDITION: _____ Fences are in serviceable condition.
Repairs needed at both gates, Broken/missing boards, Gates need repair and adjustments.

Gates Need Repairs

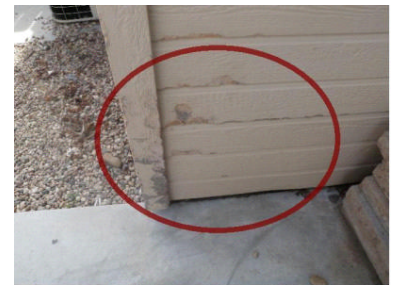
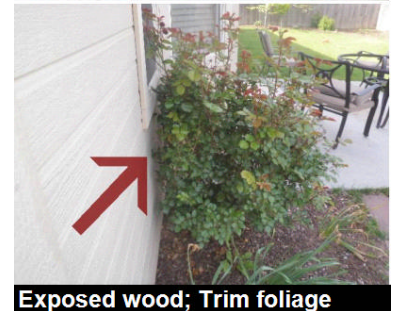
Minor damage at north side where there is exposed wood should be primed and painted. Paint is fair with only minor fading noted. Recommend trimming bushes and foliage away from the wood siding.

Exposed wood; Trim foliage

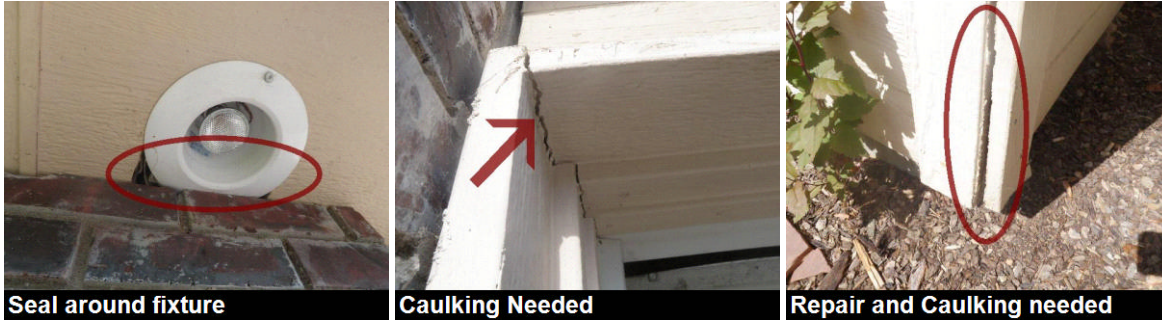
Minor Maintenance & Repair:
Separations at exterior garage lighting should be sealed to prevent potential bees nests. Other separations in caulking should be sealed periodically to prevent potential moisture intrusion. Damaged trim where swelled and separated from water damage at front entry should be repaired.

Seal around fixture

Caulking Needed

Repair and Caulking needed

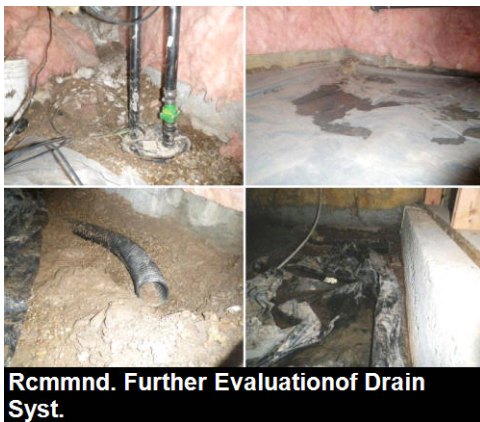
CRAWL SPACE CONDITIONS: Further Evaluation Needed:
Water intrusion problems are noted: Symptoms of prior water seepage are present; Water intrusion is noted within the crawlspace as a result of what appears to be poor drainage of soils and a high water table. A drainage system is currently installed, however there are indications that the system is not working properly as there is standing water in some isolated areas. Recommend having a reputable licensed drainage contractor make further evaluations and perform any needed repairs or improvements.

Rcmmnd. Further Evaluation of Drain Syst.

I have included the following contact information of two local drainage contractors I am comfortable to recommend:

Doug Ness / Drainage & Restoration Contractor 466-7594
Rod Poe; Aspen Mesa Water Shield; 208-724-8673.

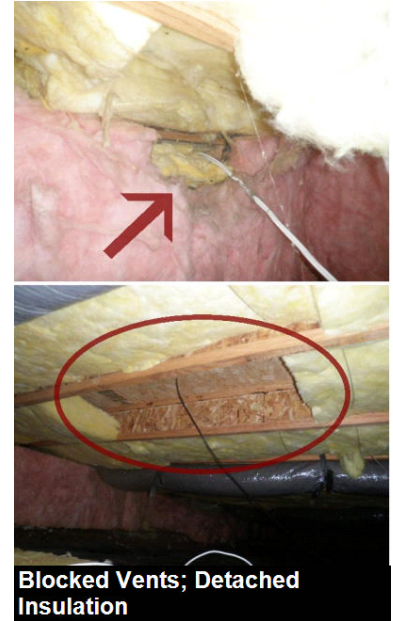
One or more foundation vents are blocked where the perimeter insulation was not properly dressed back in front of the vent(s). Recommend insulation installed directly in front of any of the foundation vents be dressed back to allow for proper airflow. Also, one area of insulation is detached at one location. This section should be reinstalled between the joists.

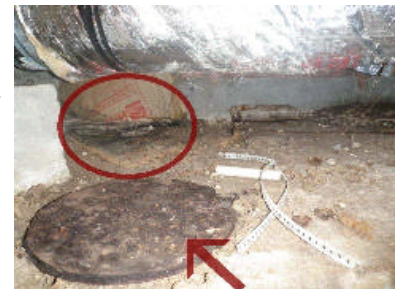
Recommend removal of wood debris and trash from the crawl space area. These items appear to contain rot and mold which can attract wood destroying organisms and other vermin especially when damp or wet.

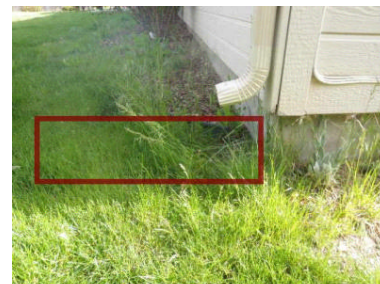
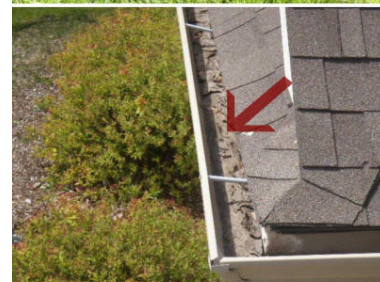
Dirt and debris in gutter should be removed from the gutters at this time. Recommend splash blocks or gutter extensions be installed at the downspouts in order to divert water away from foundation walls.

Extend Downspouts; Clean Gutters.

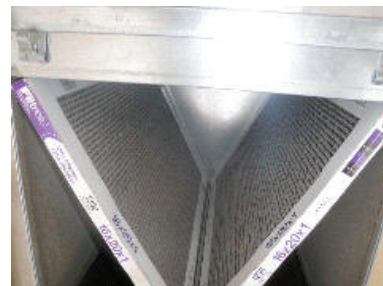
Filter condition: Dirty; Suggest cleaning/changing filters.
Furnace filter location: Above blower compartment.
Filter Sizes: 20x12x1.

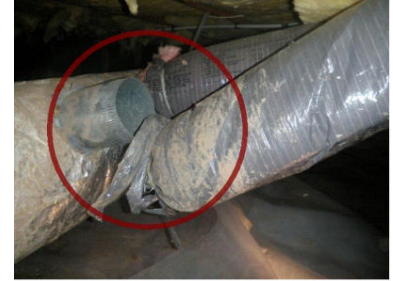
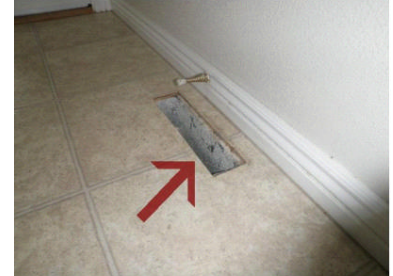
Branch duct is disconnected at main trunk in crawlspace. Repair is needed to achieve proper airflow throughout the system.

There is a missing register at the laundry room air supply at the floor.

**Disconnected Branch Duct;
Missing Register**

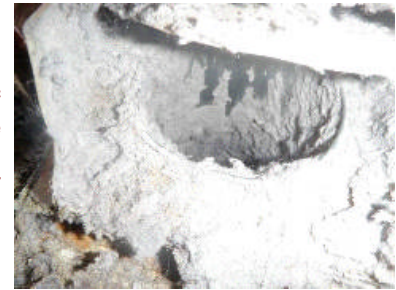
Dryer vents need periodic cleaning to avoid potential moisture problems at wall penetrations. Dryer lint is also very flammable and dryer vents have been documented as a common cause of some house fires. We recommend cleaning the dryer vent at this time. Also, the vent flap installed at the exterior vent termination point is no longer opening and closing as intended. Recommend replacing the exterior vent hood with an operating vent flap.

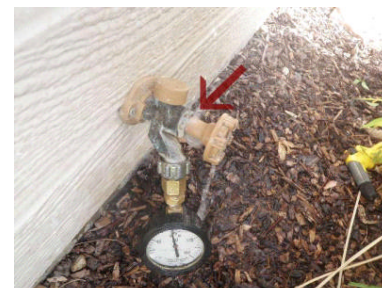
The front hose faucet handle leaks under pressure and needs repair or replacement.

Front Hose Faucet Leaks at Handle

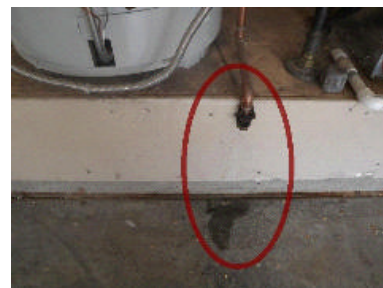
CONDITION: Water heater is working as expected. Heater is approaching it's expected service life of 12 yrs. Leakage has occurred at the Temperature & Pressure Relief Valve (TPRV). This may be due to problems with the TPRV or may also indicate the thermostat is set too high. Further evaluation and repair by a licensed plumber is recommended.

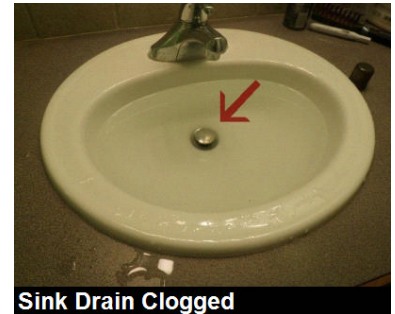
CONDITION OF SINK: North bathroom: The following problems were noted at the drain: The sink drain is clogged and drains very slowly.

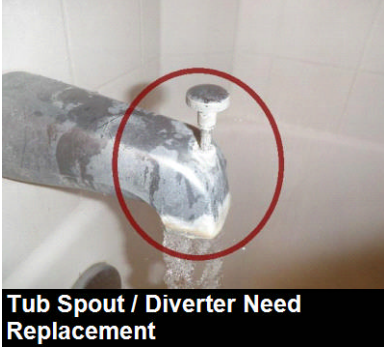
TUB/SHOWER PLUMBING FIXTURES: Appears serviceable; Performance is fair. The shower diverter/tub-spout unit needs replacement. Diverter is stuck and will not toggle.

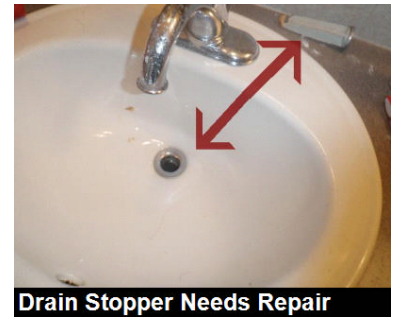
CONDITION OF SINK: Dual vanity sinks; Appear serviceable; Performance is as expected. The left sink stopper assembly is missing and needs repair.

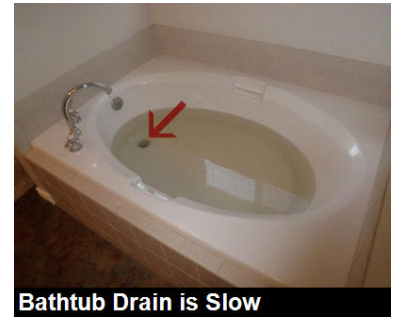
TUB/SHOWER PLUMBING FIXTURES: Appears serviceable; Performance of valves and faucets is good. The following problems were noted at the tub drain: Drain is slow at tub.

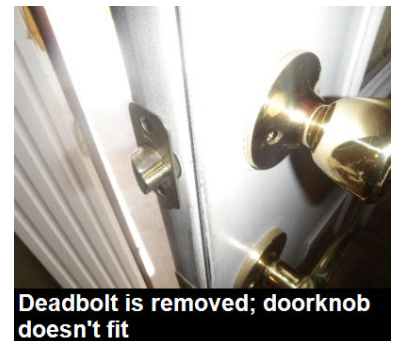
Serviceable; Average wear.
Dead Bolt is not operational and has e replaced with the wrong hardware.

Deadbolt is removed; doorknob doesn't fit

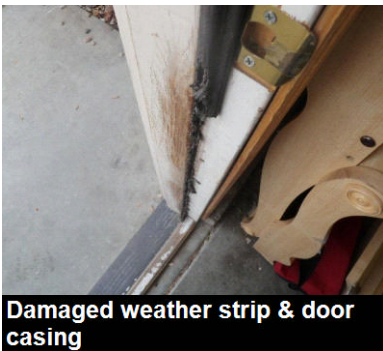
Weather strip is pet damaged and needs replacement.
Exterior door casings are pet damaged and need replacement.
Vertical blinds are pet damaged and need replacement.

Damaged weather strip & door casing

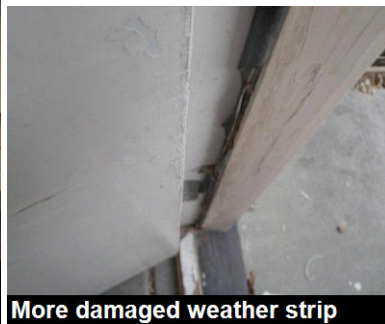
More damaged weather strip

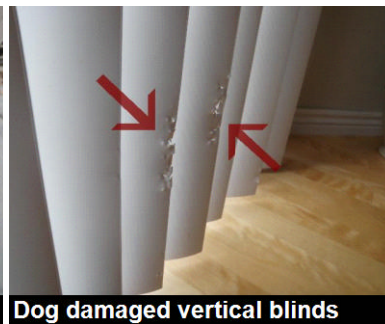
Dog damaged vertical blinds

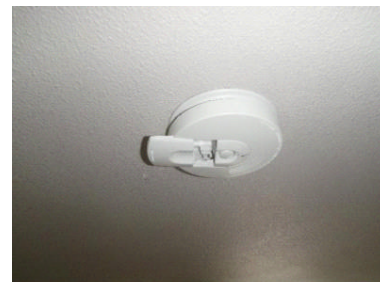
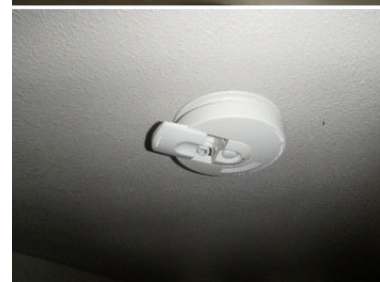
Several smoke detectors are missing their back-up batteries. Backup batteries need to be installed in the event of a fire during a power failure.

Smoke Detectors Need Backup Batteries

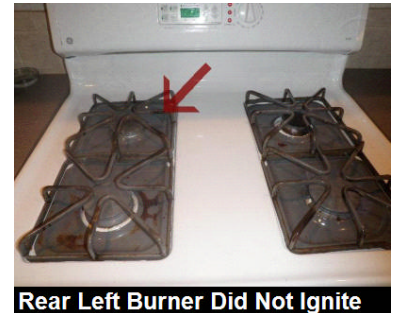
There is no anti-tip bracket installed on this free-standing device and the unit could tip forward if a small child were to stand on the open oven door. Scalding could occur if hot food or water were to then spill onto the unsuspecting child.

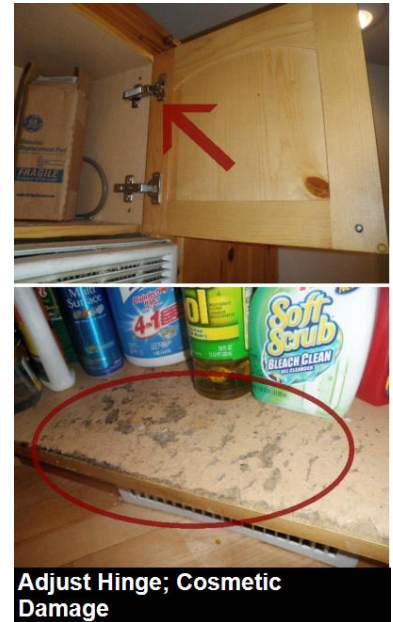
Right cabinet door above microwave is loose and needs repair/adjustment at the hinge. Cosmetic damage is noted at the floor of the inner cabinet beneath the sink.
